Manhole Inspection Summary

Manhole # S47II_015MH

Insp Date: **3/5/10 1:16 PM**

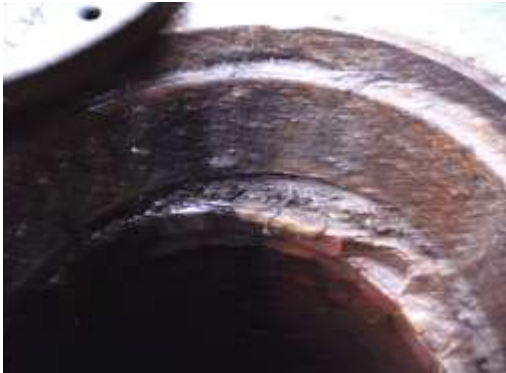
Defect 4

Frame Offset: **2** (in.) Condition: ☒ Sound ☐ Cracked ☐ Leaks

frame offset

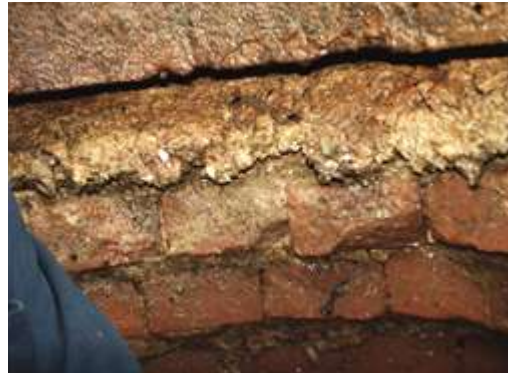
Defect 3

Infiltration: ☐ None ☐ Joint ☐ Cracks ☒ **Mortar** ☐ Roots ☐ Wall

Infiltration: ☐ None ☐ Joint ☐ Cracks ☐ Mortar ☐ Roots ☒ **Wall**

infiltration

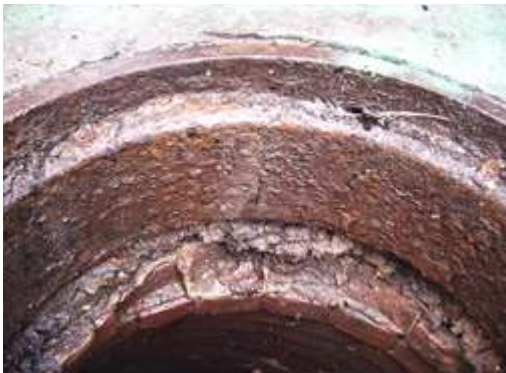
Defect 2

frame leaks

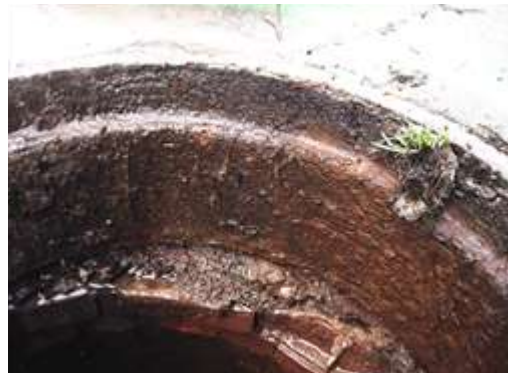
Defect 1

off set

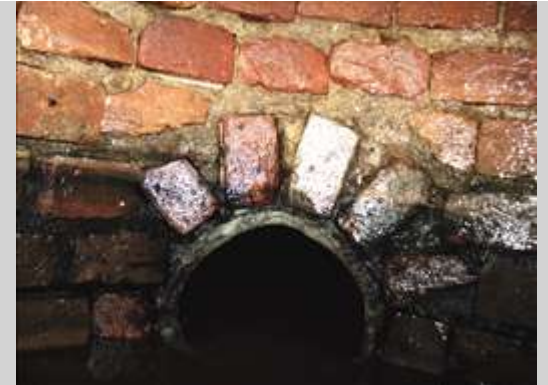
12 O'Clock Outflow

8 in. Circular Gravity Sewer
Pipe Out @ 12 O'Clock

Infiltration: **None** Pipe Seal Cond: **Sound**
